## **Thermal Imaging of Canals for Remote Detection of Leaks: Evaluation in the United Irrigation District**

**Texas Water Resources Institute Technical Report  
November 2008**

Yanbo Huang and Guy Fipps, P.E.<sup>2</sup>

December 20, 2002

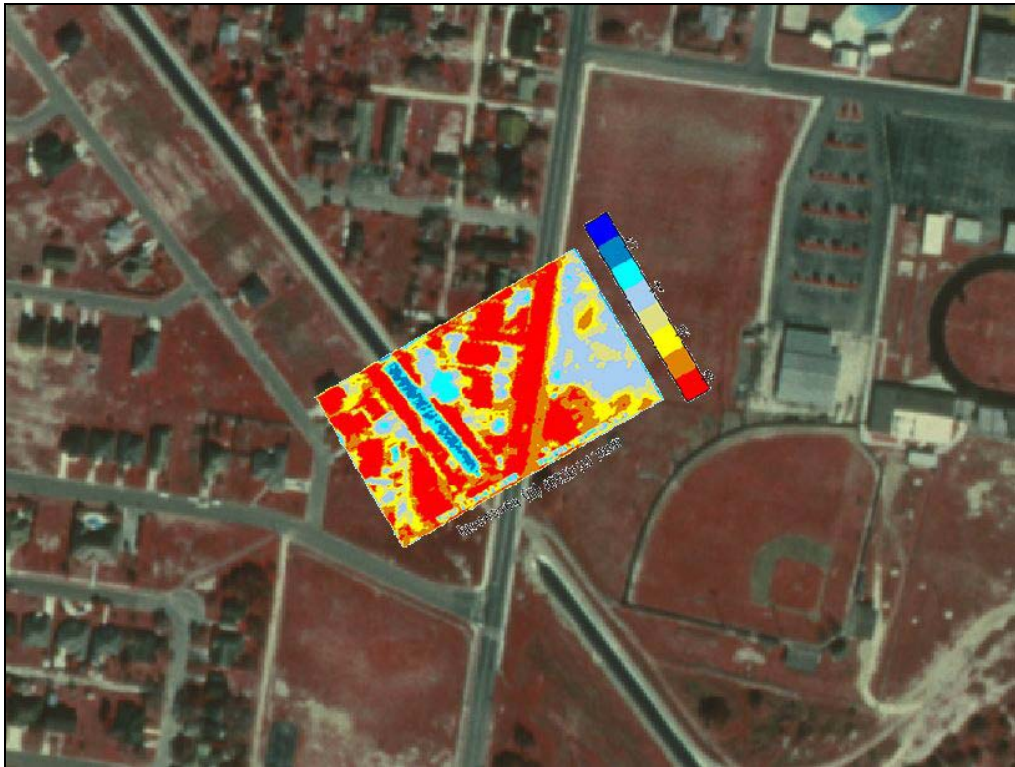
Figure 3b. Site 2 – thermal image inverted and overlaid onto the DOQQ.

As shown in Figure 3a, the thermal image shows two areas of wetness (mark circled on the image) on either side of the canal. Figure 3b shows the inverted image overlaid onto the DOQQ (Figure 3b). The results of the field evaluation are as follows:

- Wetness: 1
- Vegetation:
  - Grass – 2
  - Trees – 2
  - Crops – 0
- Seepage: 1
- Cracks: 1
- Holes: 0

Site photographs (Figure 3c-d) show a structure on the side of the canal which appears to be an abandoned gate through which water is flowing. As this is the only place along the canal with thick vegetation, the abandoned gate is likely the only source of the leak.

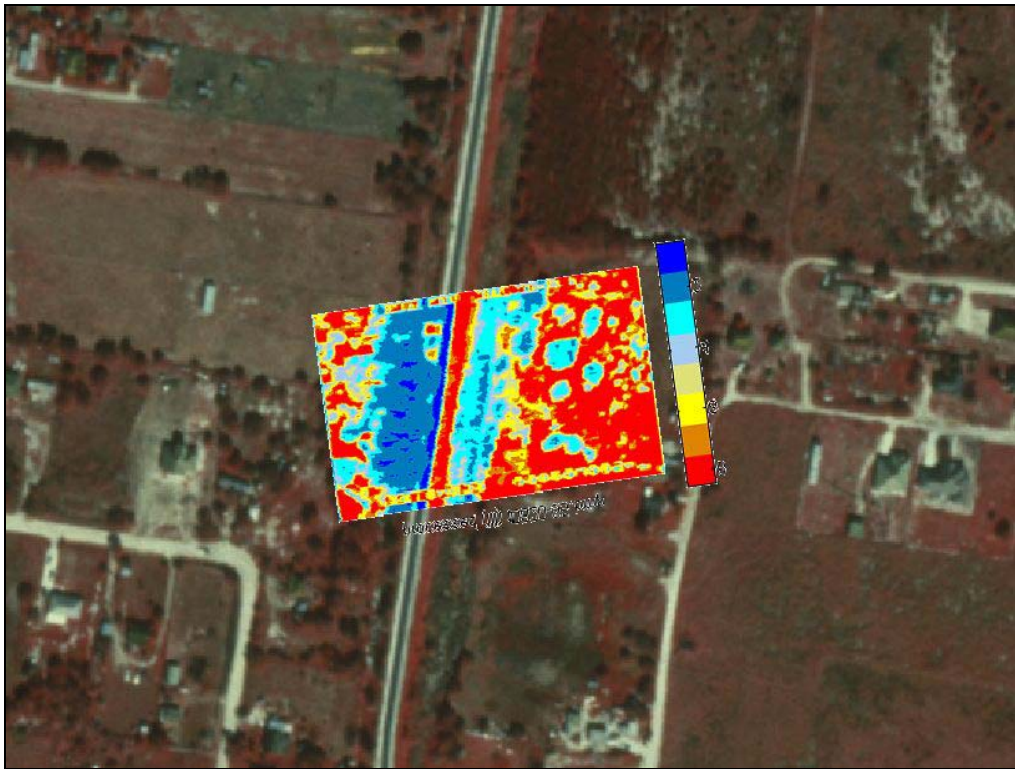
Figure 4b. Site 3 – Inverted thermal image, overlaid onto the DOQQ.

As shown in figure 4a, there is likely a seepage area along one side of the canal (left side on the image). The rating of this site is as follows:

The field photograph (Fig. 4c) shows thick vegetation on the side of the canal having and many cracks. Some of the cracks are sealed but others are not. These unsealed cracks appear to be the cause of the seepage from this canal segment.

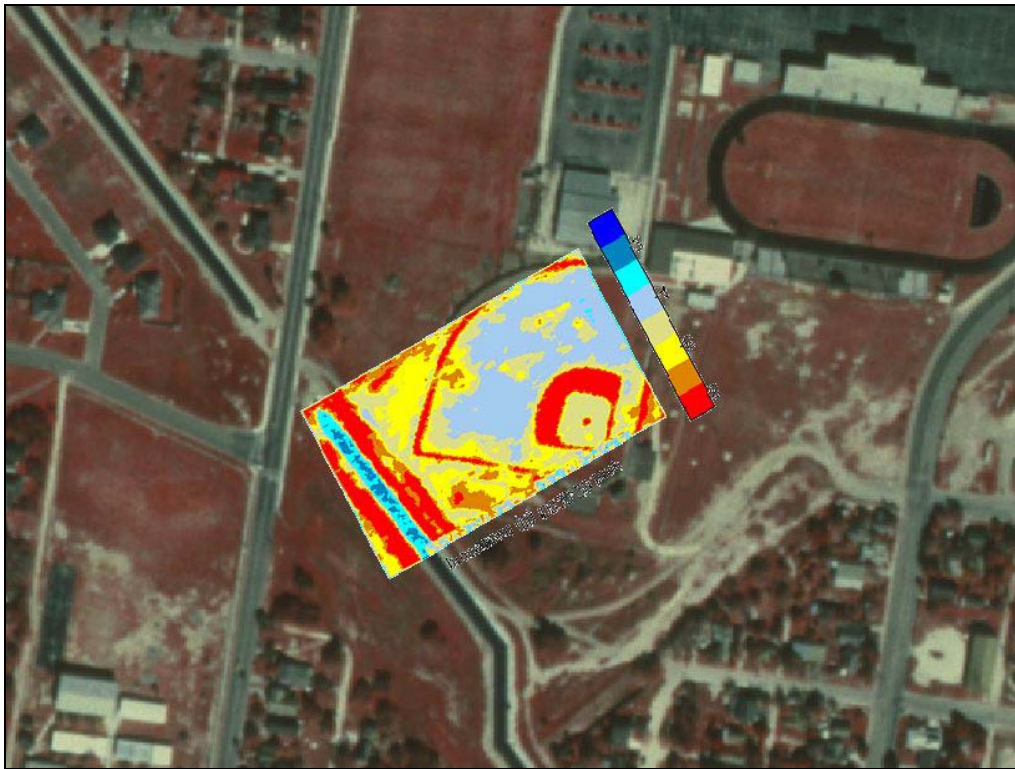
Figure 5b. Site 4 - inverted and overlaid onto DOQQ.

Figure 5a shows a canal segment beside a baseball field. While there is no indication of vegetation or wet areas along this segment, there is something other than a dirt road (line-marked on the image). This image was inverted and overlaid on the DOQQ image (Fig. 5b). The rating results are as follows:

The photograph (Fig. 5c) shows some dead vegetations spread over the sides of the canal, but otherwise the conditions of the canal is good. This canal segment does not have a detectable leak.
